## **RE: Wetland Delineation Report – The First Cathedral Church, Bloomfield, Connecticut**

On December 3<sup>rd</sup> and 4<sup>th</sup> 2024, BSC group Inc. conducted a Wetlands and Watercourse delineation at the First Cathedral Church in Bloomfield, CT. The delineation was completed in accordance with the Connecticut Inland Wetlands and Watercourses Act (Connecticut General Statutes [CGS] Chapter 440, Sections 22a-36 through 22a-45), the Town of Bloomfield Inland Wetlands and Watercourses Regulations, and the methodologies outlined in the U.S. Army Corps of Engineers (USACE) Wetlands Delineation Manual (1987), together with the Regional Supplement to the Corps of Engineers Wetland Delineation Manual: Northcentral and Northeast Region, Version 2.0 (2012).

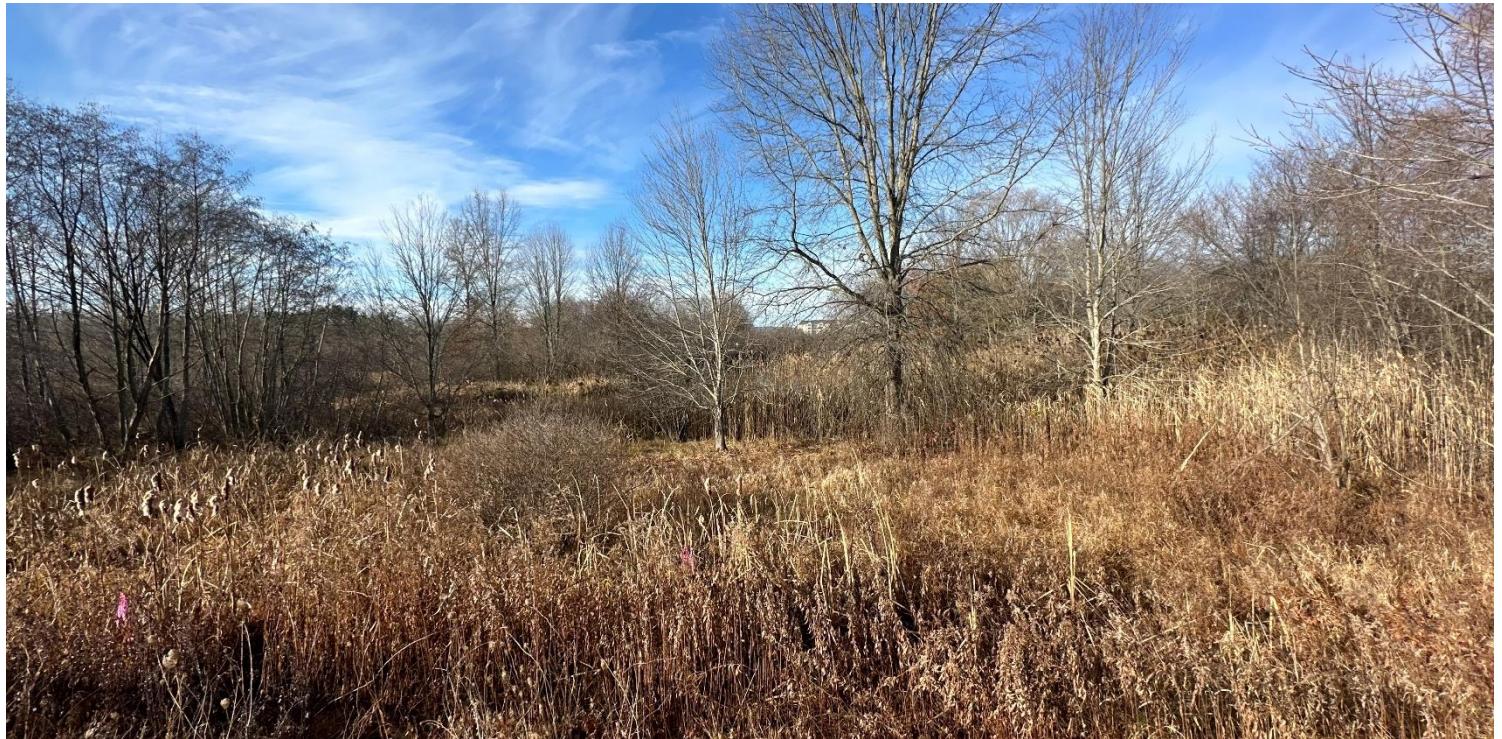
**Photo #1:** View of Wetland 1 in proximity to PO1 and SB2. *Facing west.*

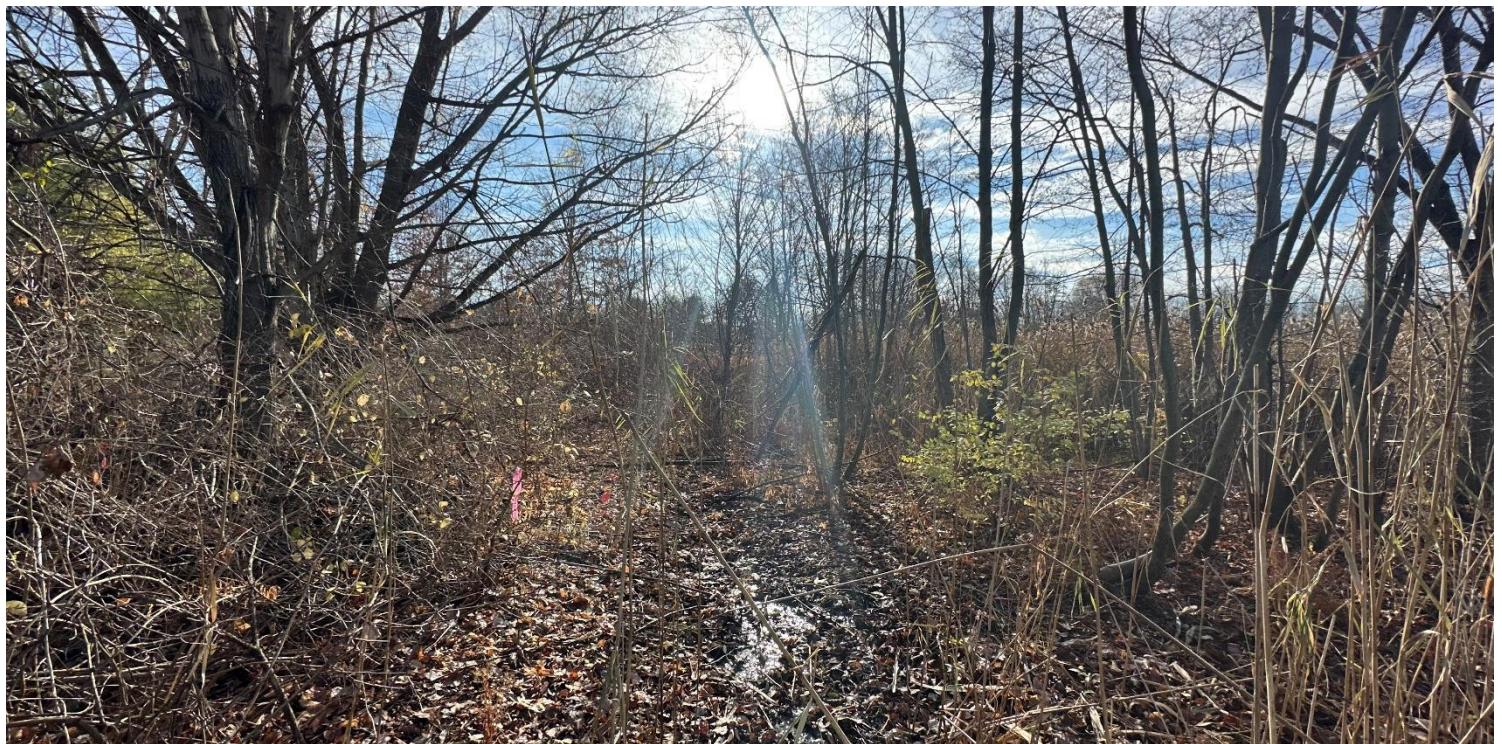
**Photo #2:** View of Wetland 1 in proximity to SB1. *Facing south*

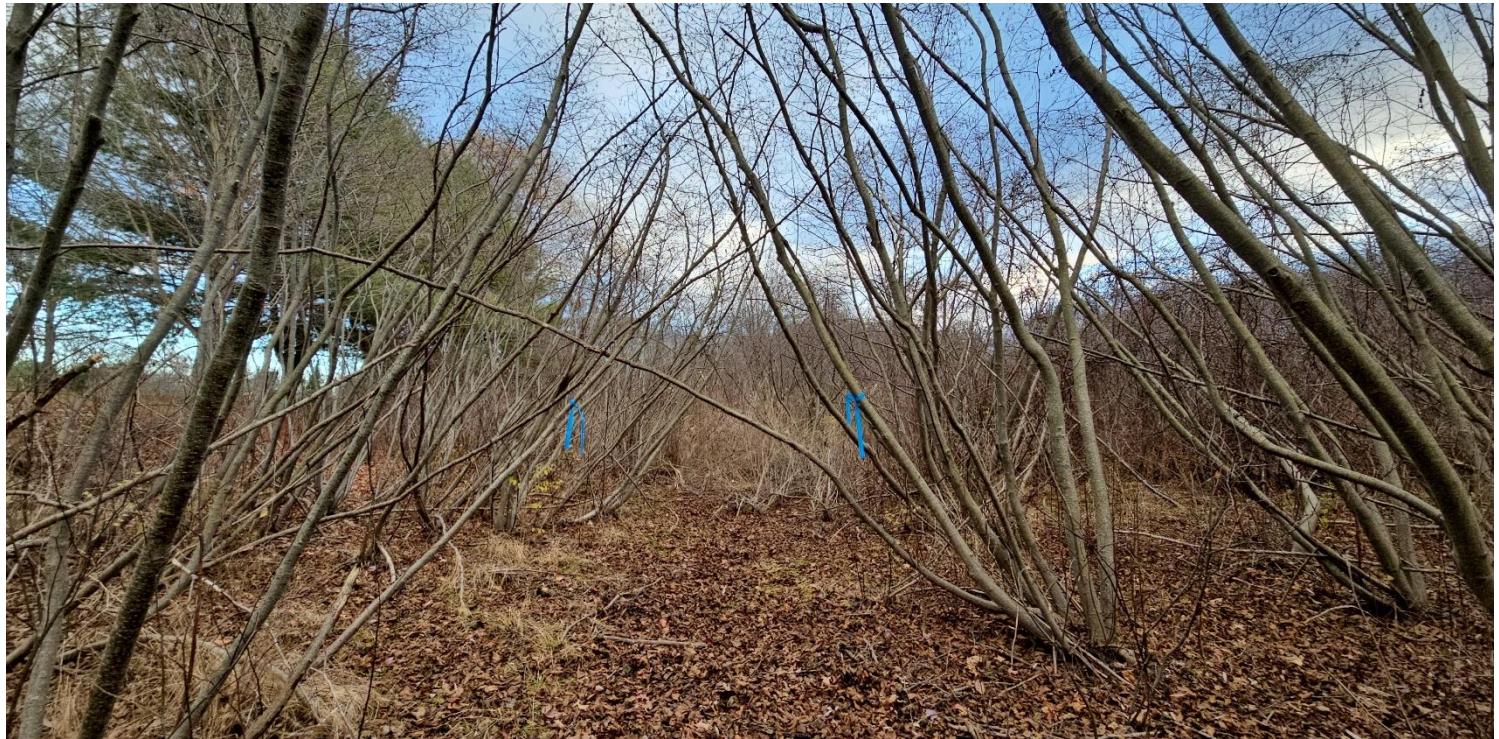
**Photo #3 :** View of SB1 showing a dry intermittent channel within W1. *Facing southeast.*

Hydrology in W1 is influenced by two intermittent watercourses (SB1 and SB2) that flow north and west toward the onsite pond. SB1 exhibits a fine silt and clay substrate with a bankfull width of approximately 4 feet and a bankfull depth of approximately 6 inches. The watercourse was observed dry during the site visit, with diffuse flow indicators present both upslope and downslope of the delineated segment. SB2 has an approximate bankfull width of 5 feet and a bankfull depth of around 8 inches, with banks 8 to 10 inches in height. The banks of SB2 are vegetated with speckled alder, Meadowsweet, common reed, and cattail. A pond is located within W1, with a bank dominated by speckled alder, cattail, and common reed (*Phragmites australis*). Ordinary high-water indicators were present along the bank surface.

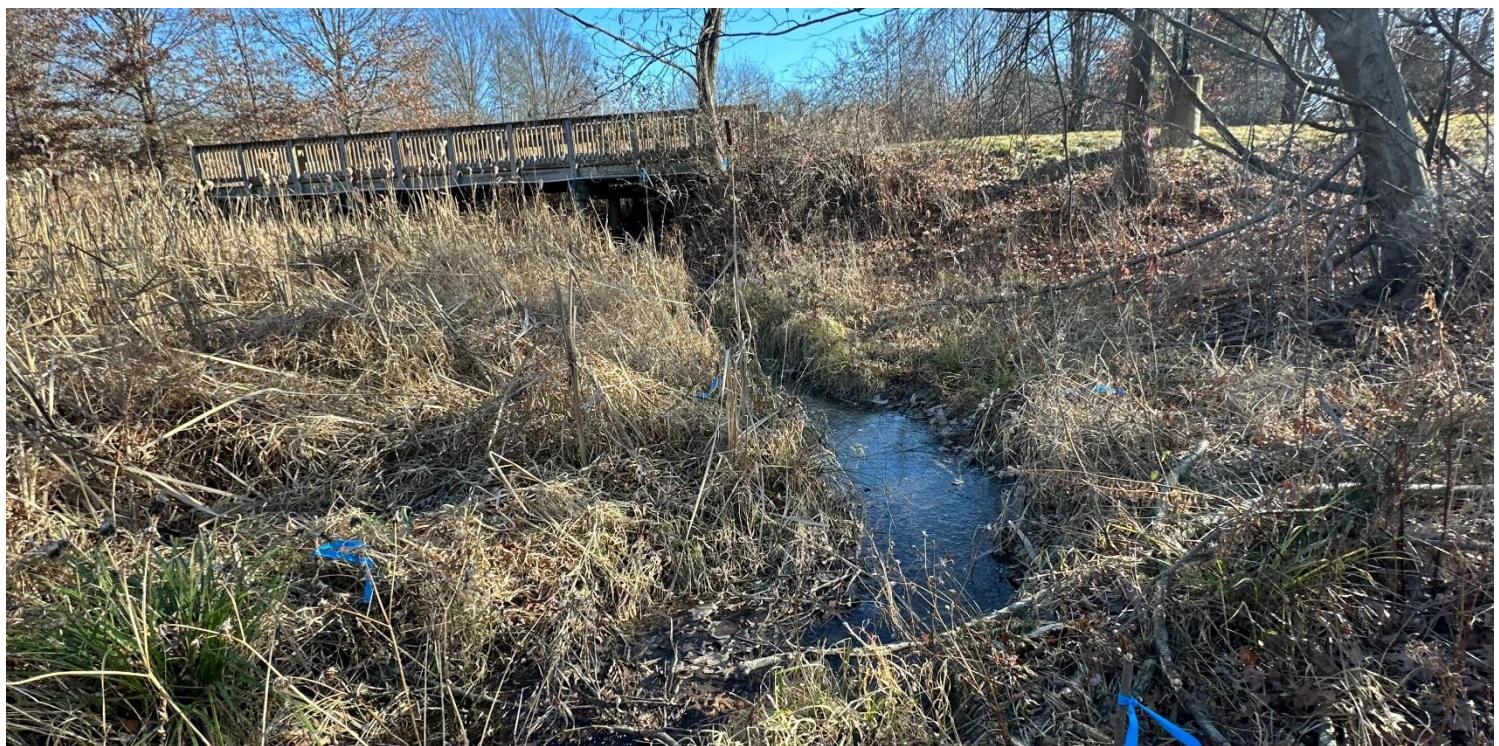
**Photo #4 :** View of SB2 showing a frozen intermittent channel within W2. *Facing east.*

connectivity with Wetland W1. SB2 exhibits an average bankfull width of approximately 5 feet and an estimated bankfull depth of approximately 8 inches. The channel was flowing during the inspection, high-water indicators, minor scour, and fine sediment deposits were also present. Banks range from 8 to 10 inches in height and are more distinctly defined than those observed along SB1. Bank vegetation is dominated by speckled alder, white meadowsweet, common reed, and cattail. The channel substrate consists primarily of fine silt and clay. SB2 conveys seasonal stormwater and contributes hydrologic movement toward the onsite pond as part of the site's drainage network.
